(10) International Publication Number  
**WO 01/42802 A1**

(54) Title: METHOD FOR DIAGNOSING DEGRADATION IN AIRCRAFT WIRING

## METHOD FOR DIAGNOSING DEGRADATION IN AIRCRAFT WIRING

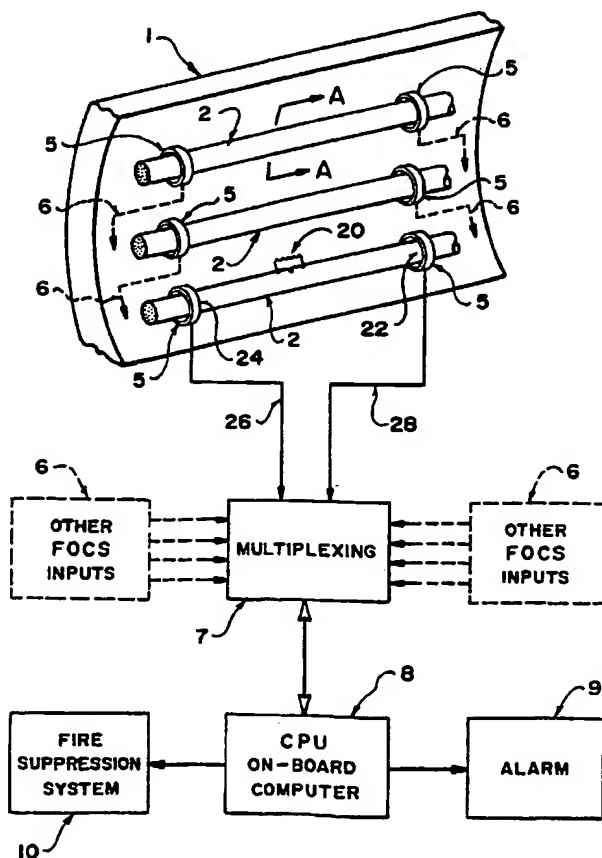
(57) Abstract: Wiring in new and older aircraft use bundled insulated conductors that are subject to deterioration over time that can result in on-board fires, loss of in-flight control and eventual crashes of the aircraft. The present invention provides a diagnostic method which permits the on-line and non-destructive diagnosis of the insulation degradation in a portion of the wiring comprising: a) measuring the current flow at locations of the aircraft wiring utilizing an optical current sensor with a bandwidth of dc to 50 kHz; b) determining the current flow within a high frequency bandwidth; and c) analysing the results of the current flow differential determination and initiate the following: i) detect and locate the point of cable failure; ii) initiate an alarm annunciation; and iii) initiate an on-board sectionalized fire suppression system.

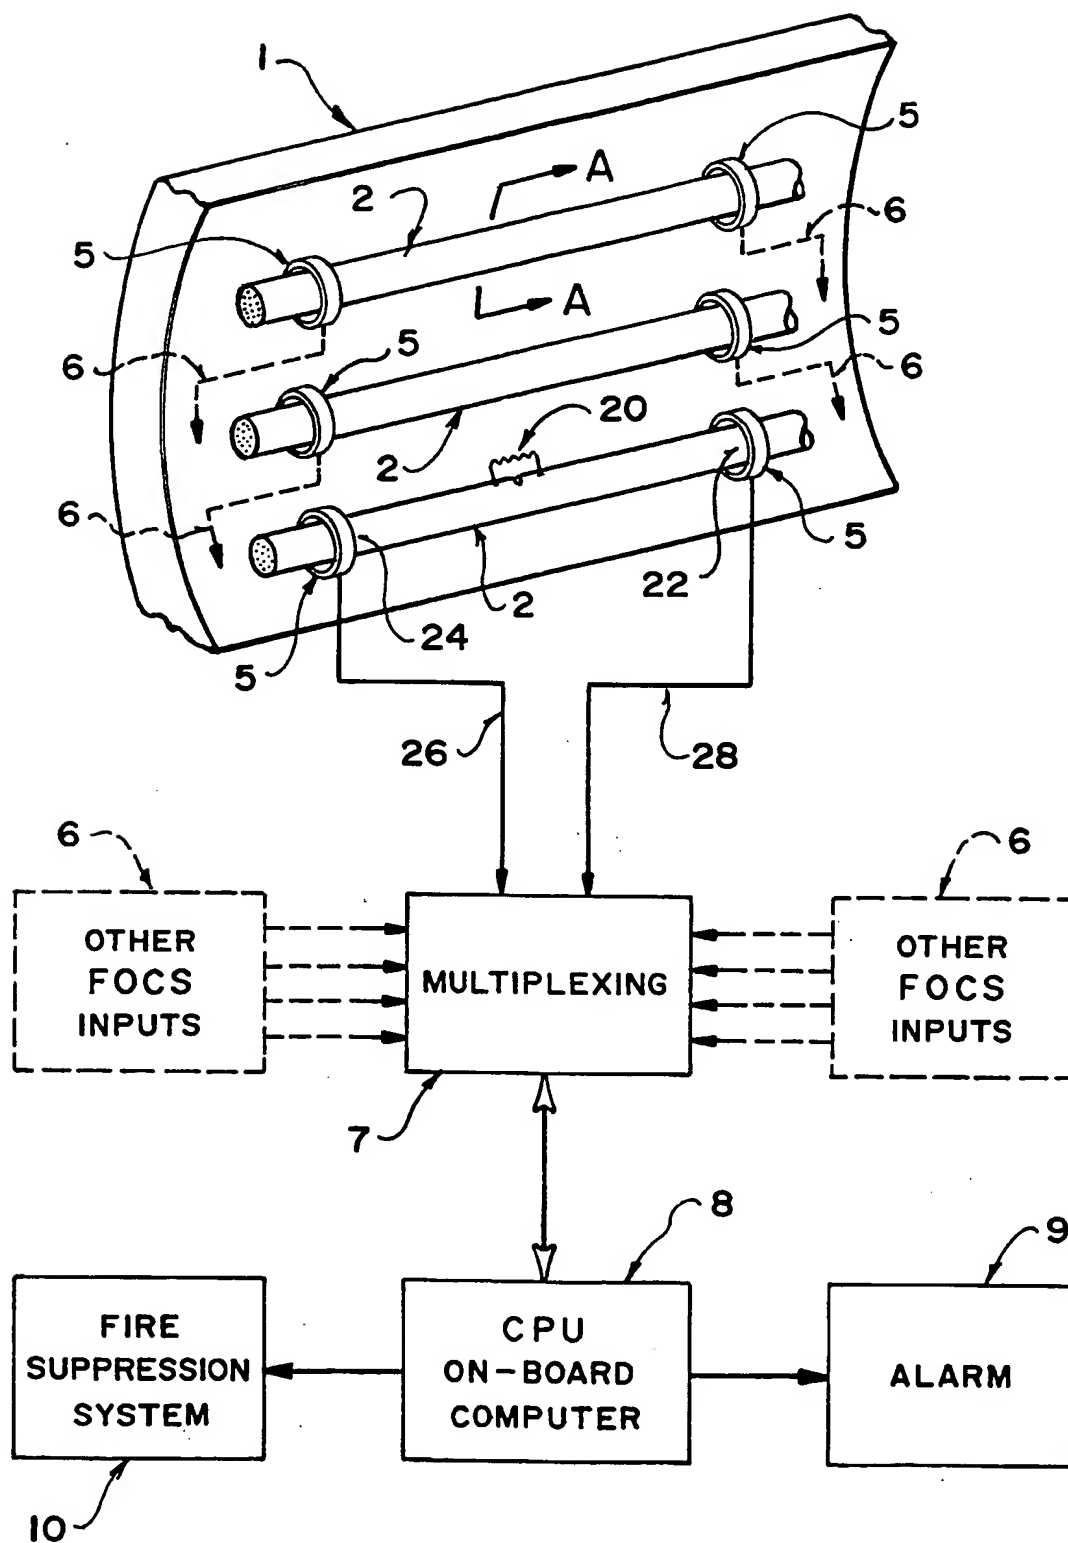
FIG. 1

- 5        Fig. 1 is a schematic illustration and block diagram of an aircraft wiring system with the proposed diagnostic; and  
      Fig. 2 is a cross-section taken along lines A-A of Figure 1 of a typical wiring cable used in an aircraft.

- With reference to Figures 1 and 2, a standard aircraft wiring cable (not to scale), designated as 2, carries an electrical current, typically from a few milliamperes to 10's of amperes at 400 Hz. The cable consists of solid or  
15    stranded conductors of copper or aluminum, insulated with PTFE or Polyimide and twisted in pairs 3 and bundled into a large cable with an overall jacket 4. Power conductors are typically single core, whereas the control cables are twisted pairs. Some of these cables also carry direct current, although most carry the 400 Hz ac current generated by the airplane's generator. These cable  
20    bundles are mounted on the aircraft fuselage 1 or in cable trays and electronics bays inside the aircraft.

- Extremely accurate optical current sensors 5, which may be fibre, slab or crystal are now available to measure the flow of current in the aircraft  
25    wiring. Such sensors have a resolution of  $5 \times 10^{-6}$  amperes and a bandwidth of dc to 50 kHz. Optical sensors of this general type are typically manufactured by Sumitomo in Japan and others. A suitable optical current sensor is wrapped around or clipped over the cables 2 at two spaced locations 22, 24. The light within the fibre, slab or crystal is perturbed by the electromagnetic field  
30    produced by the current in the conductor and the sensor can be calibrated to measure the current in the conductor with sufficient accuracy and linearity. The output from each optical sensor is communicated to the central processing unit or CPU 8 via conductors 26, 28 and a multiplexer 7 that allows

simultaneous processing of multiple signals 6 from multiple fibre optic current sensors. The CPU 8 calculates the difference between the cable conductor current flows at 22 and 24 at different frequencies, within a bandwidth excluding 400 Hz. To reduce the effects of background noise, time averaging  
5 of the data may be carried out over an extended period. Since sparking or an arc discharge 20 generates a high frequency component in the range of 10 kHz to 50 kHz, readings are taken at frequencies in the 10 kHz to 50 kHz range. The differential is then processed by the CPU 8 at those frequencies, the data is analyzed by the CPU and the presence and location of a potential cable wiring  
10 fault may be indicated based on that analysis. The CPU will generate an alarm 9 and depending upon the received signal level from the sensor will initiate a sectionalized fire suppression system 10.

The location of the cable wiring fault or sparking may be calculated by  
15 the CPU 8 using a technique called time domain reflectometry or TDR. This method is disclosed in the following publication: Matthew S. Mashikian, "Partial Discharge Location as a Diagnostic Tool for Power Tools" 1999 *IEEE/PES Transmission and Distribution Conference*, New Orleans La., April 11-16, 1999, Panel on Diagnostic Measurement Techniques for Power Cables.  
20 See in particular Figure 3.

Single, open-ended current sensors 5 can also be positioned at single locations on cables which are connected to the aircraft chassis or ground in order to detect sparking or different harmonics. A second diagnostic may also  
25 be performed, namely determining the harmonic component of the 400 Hz insulation leakage current to establish the degree of insulation deterioration that has occurred. A badly deteriorated cable will show a leakage current (differential) in a given range at a particular frequency. The method of carrying out the harmonic current analysis is described in the following publications: K.  
30 Hirotsu, K. Hosoe et al., "Development of Hot-line Diagnosis Method for XLPE Cables by Measurement of Harmonic Current" in *Proceedings of the Symposium on Electrical Insulation Materials*, Osaka Japan, september 1994, Vol. 26, pp. 455-458; J. Densley, "Aging and Diagnostics in Extruded Insulation for Power Cables" in *Proceedings of the 6th International*
